DEPARTMENT OF TRANSPORTATION**DIVISION OF ENGINEERING SERVICES**

Contract #: 04-0120F4Cty: SF/ALA Rte: 80 PM: 13.2/13.9File #: 69.28**WELDING INSPECTION REPORT****Resident Engineer:** Pursell, Gary**Address:** 333 Burma Road**City:** Oakland, CA 94607**Report No:** WIR-001889**Date Inspected:** 05-Apr-2008**Project Name:** SAS Superstructure**OSM Arrival Time:** 630**Prime Contractor:** American Bridge/Fluor Enterprises, a JV**OSM Departure Time:** 1730**Contractor:** Zhenhua Port Machinery Company, Ltd (ZPMC), Changxing Island **Location:** Shanghai, China

Bridge No: 34-0006 **Component:** OBG side and bottom panels

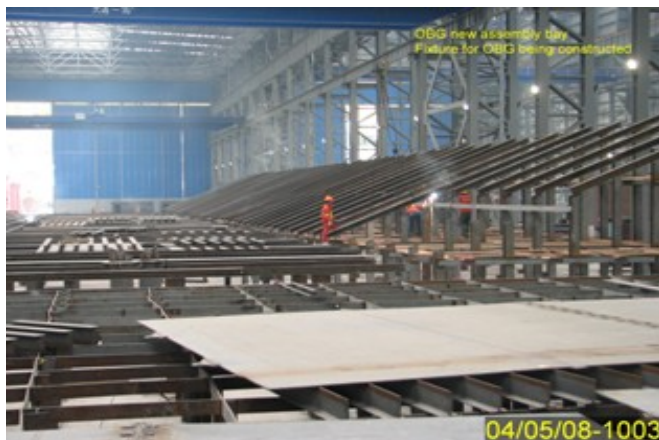
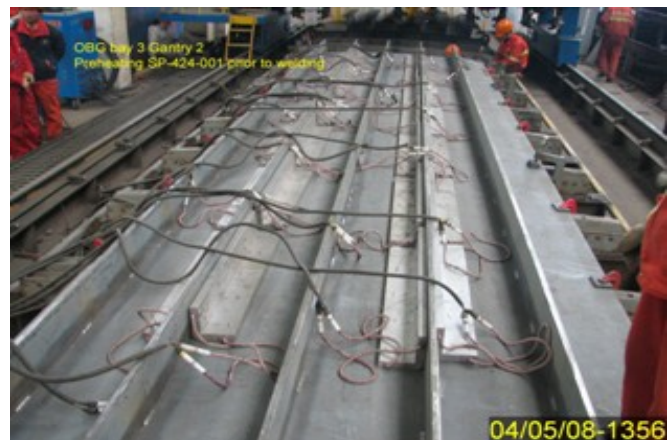
QA observed ZPMC qualified welding personnel perform the SAW intermediate and cap welds on side panel SEG-013A-002. ZPMC QC inspectors were observed monitoring the weld parameters for compliance to the posted WPS. They appeared to comply and are as follows:

Volts: 32 Amps: 633 Travel Speed: 487mm/m

QA observed a variety of other operations in this area including construction of the OBG fixture, trimming, cleaning and grinding OBG side and bottom panels.
